1. REPORT NO.		2. GOVERNMENT ACCESSION NO.		3. RECIPIENT'S CATALOG NO.	
4. TITLE AND SUBTITLE Evaluation of the Ion Exchange Landslide Correction Technique				5. REPORT DATE January 1973

9. PERFORMING ORGANIZATION NAME AND ADDRESS Materials and Research Department California Division of Highways Sacramento, California 95819				10. WORK UNIT NO.

Final Report
M&R No. 632116
D-5-38

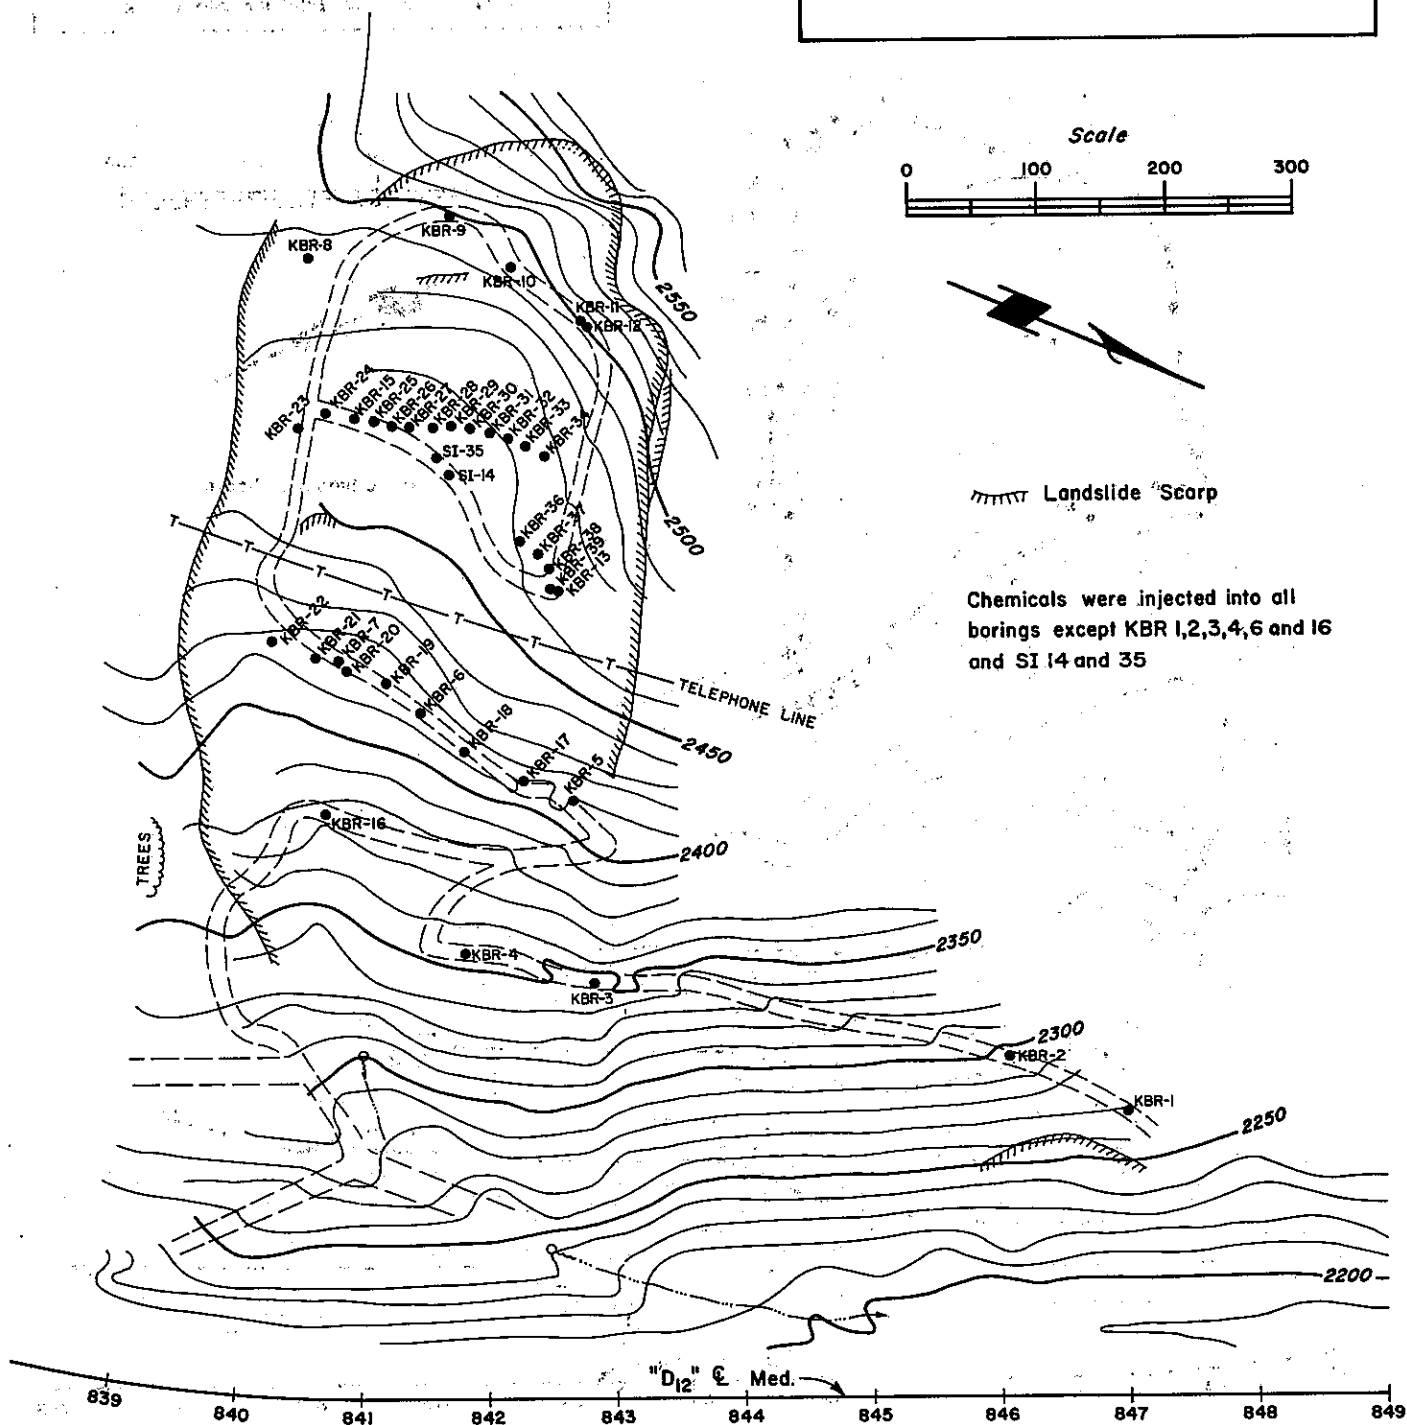
Figure 3

A total of 31 borings were used for injecting chemicals into the slide. The locations of these borings are shown on Figure 3. Twenty-two of the borings were drilled specifically for chemical treatment at locations specified by Ion Tech, Inc. Nine previously drilled sample borings were also used to provide wider chemical distribution.

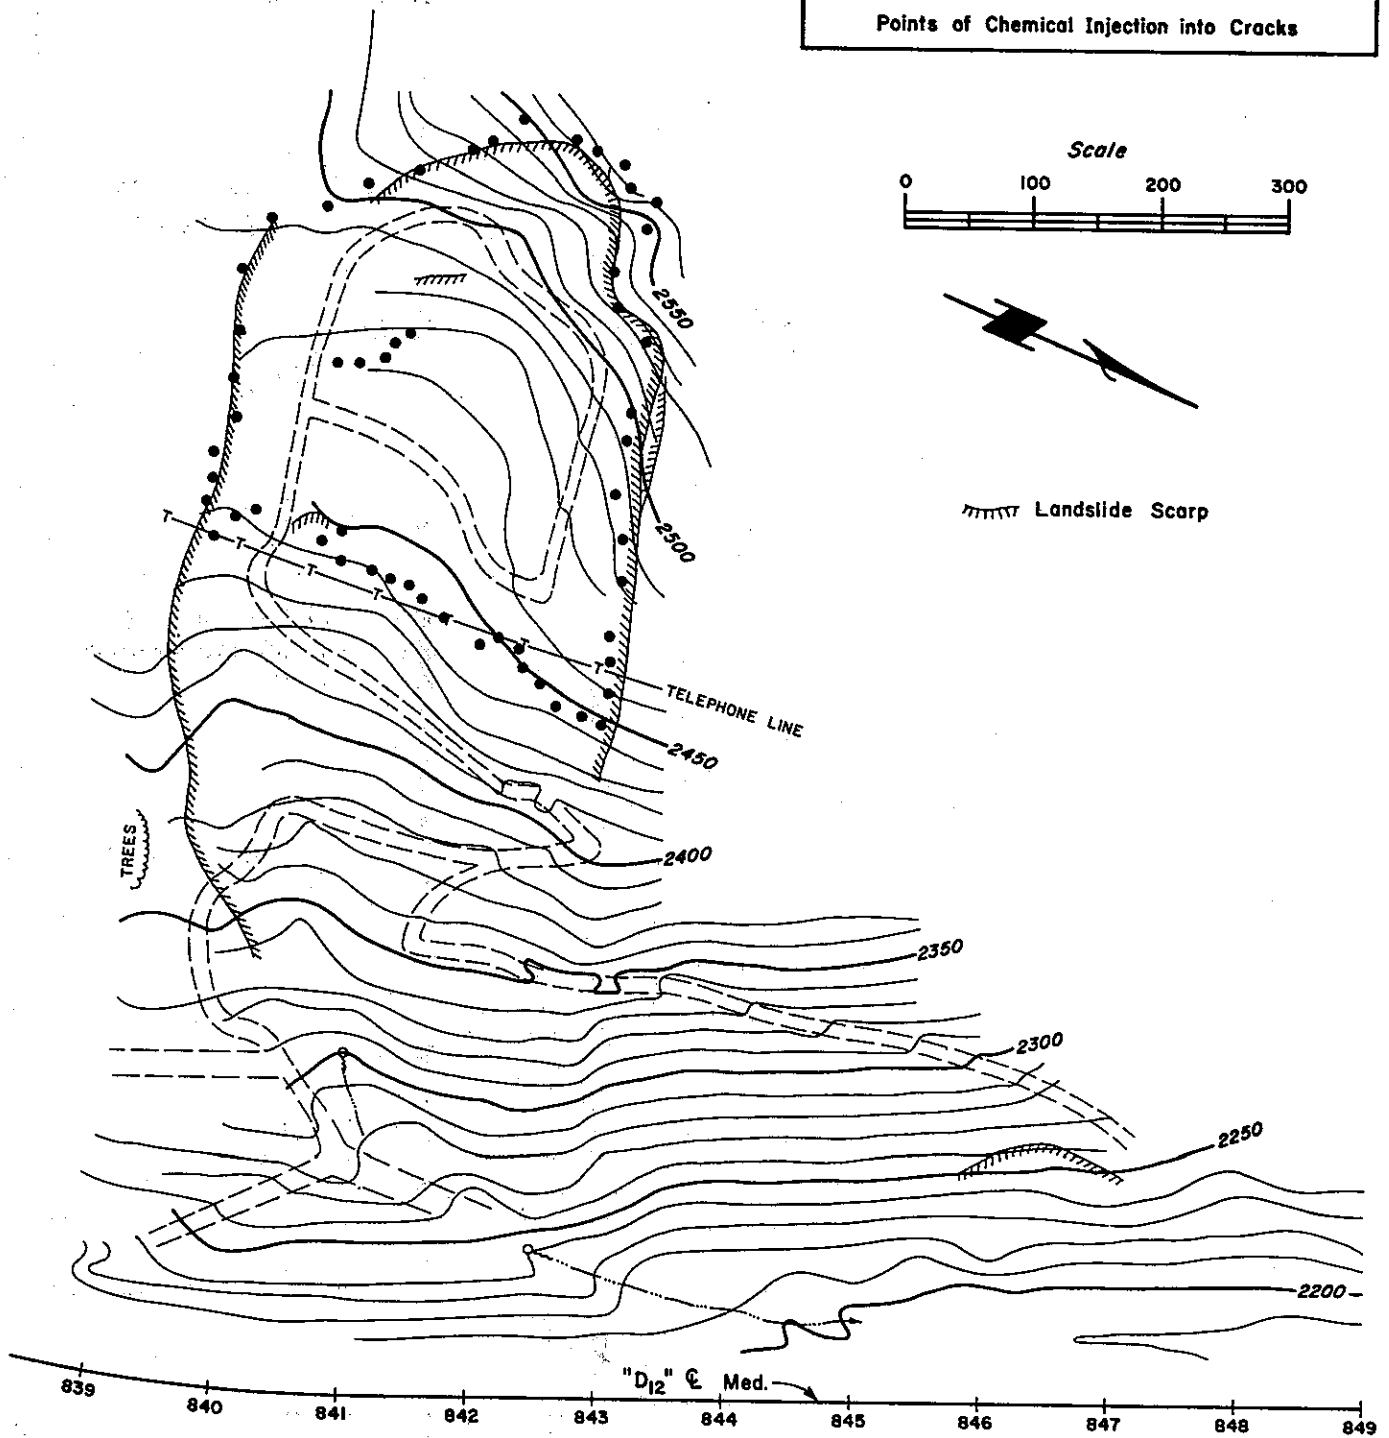
MATERIALS AND RESEARCH DEPARTMENT
 ION EXCHANGE LANDSLIDE CORRECTION
 ROAD 02-Sha-5 PM 65.2
 PLAN
 Points of Chemical Injection into Cracks

Fifty-five injection points in cracks were utilized. These injection points are shown in Figure 4 and were selected in the field under Mr. Graf's direction.

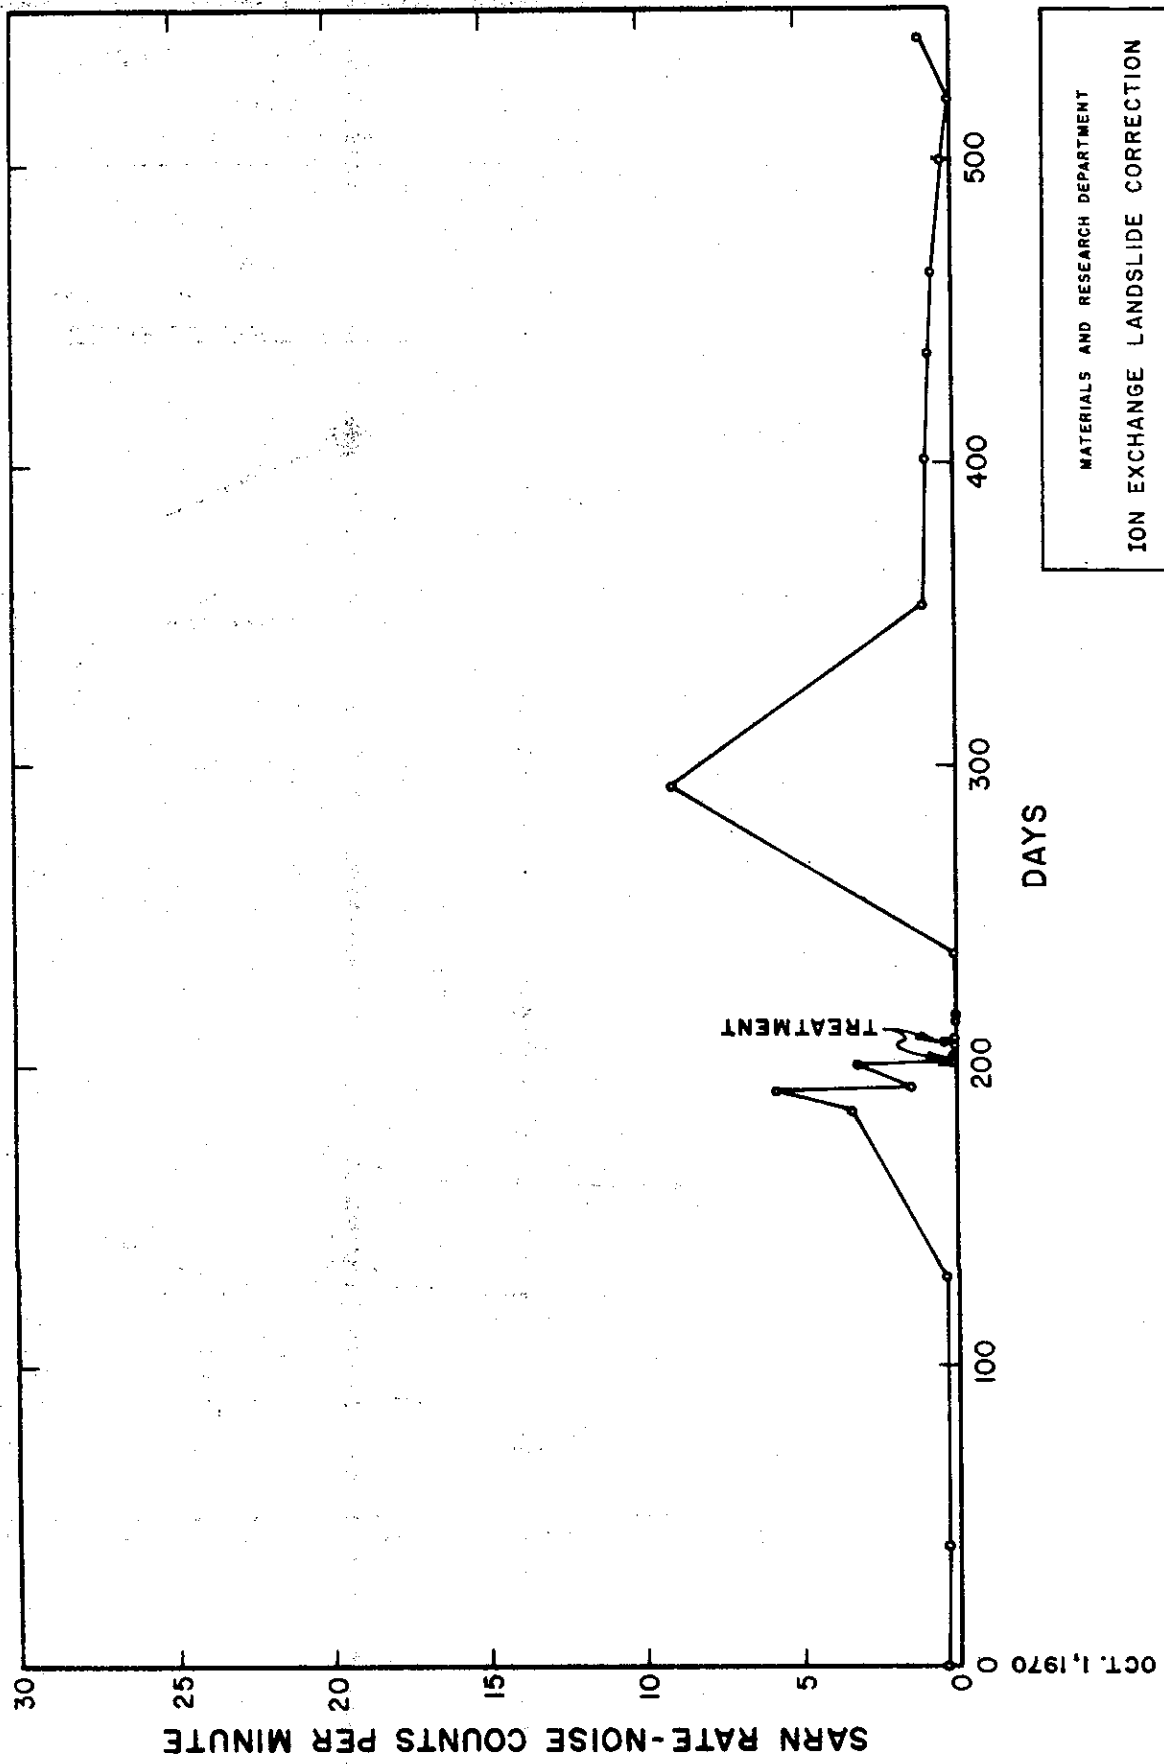
Figure 6

The tabulated data has been plotted in Figures 6 through 9. Inspection of Figures 6 and 7 show that the noise rate for borings KBR-4 and KBR-6 apparently declined and stabilized after the chemical treatment. However, the noise rates of SI-14 and SI-35, located about 15 feet apart, were found to be higher and more erratic subsequent to chemical treatment as shown on Figures 8 and 9.

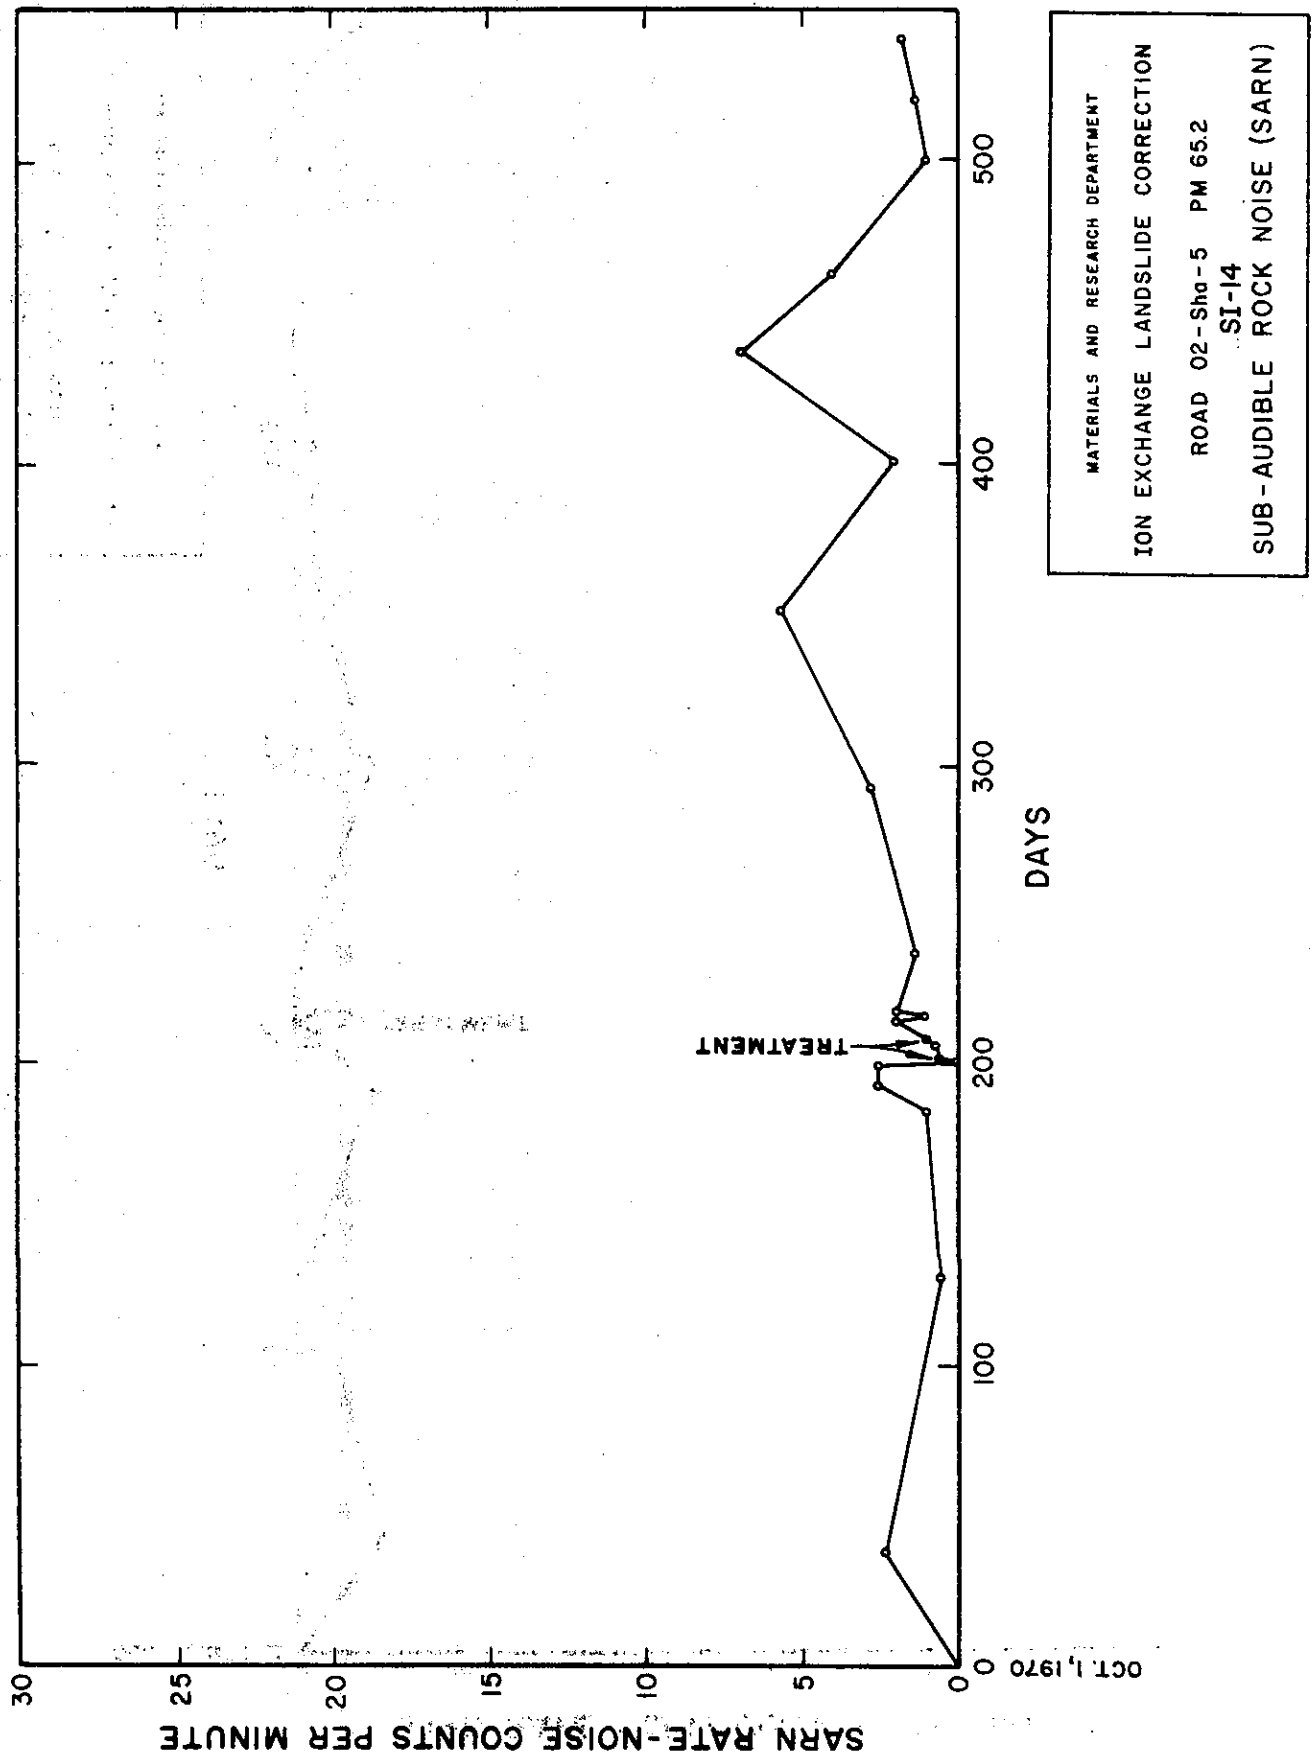
Figure 8

Our interpretation of these results, in the absence of any indication of renewed sliding, is that the slide mass is either settling or adjusting internally as the hill becomes more stable. Based on SARN observations on other landslides, the noise rates on this slide are not high enough to suggest active movement. This was true of the year before chemical treatment as well as the year after.

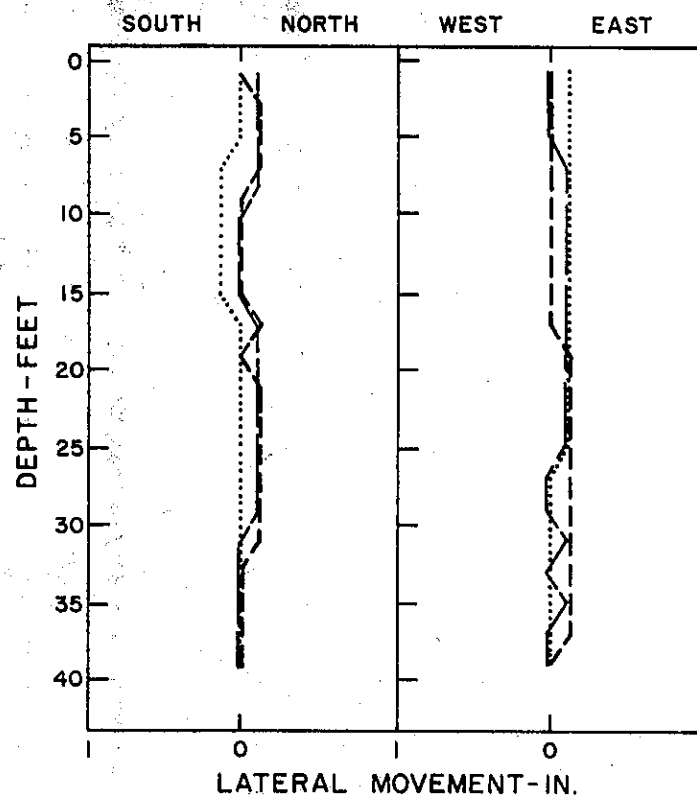
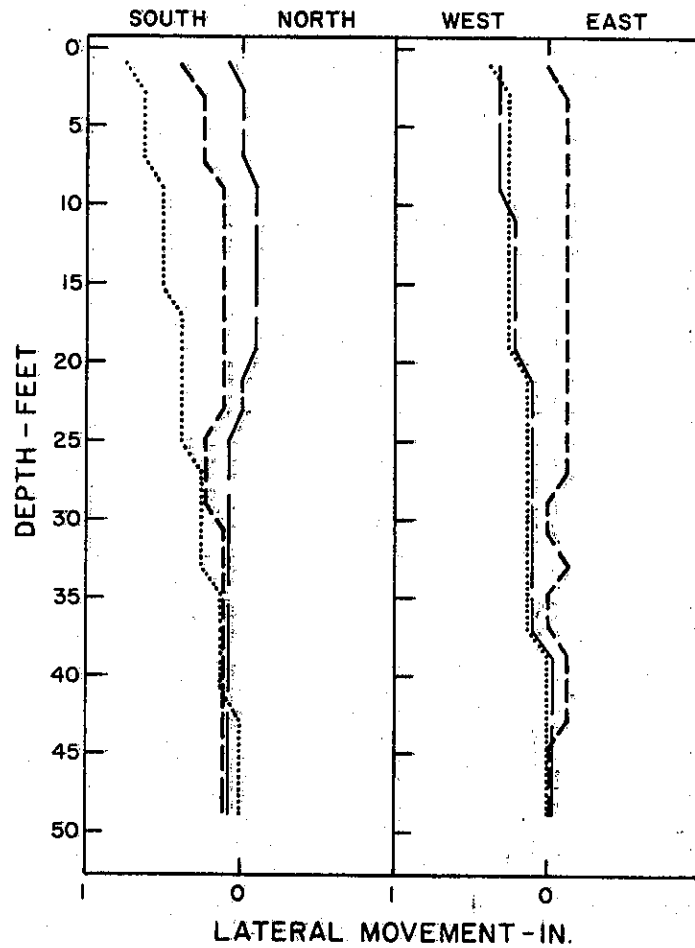
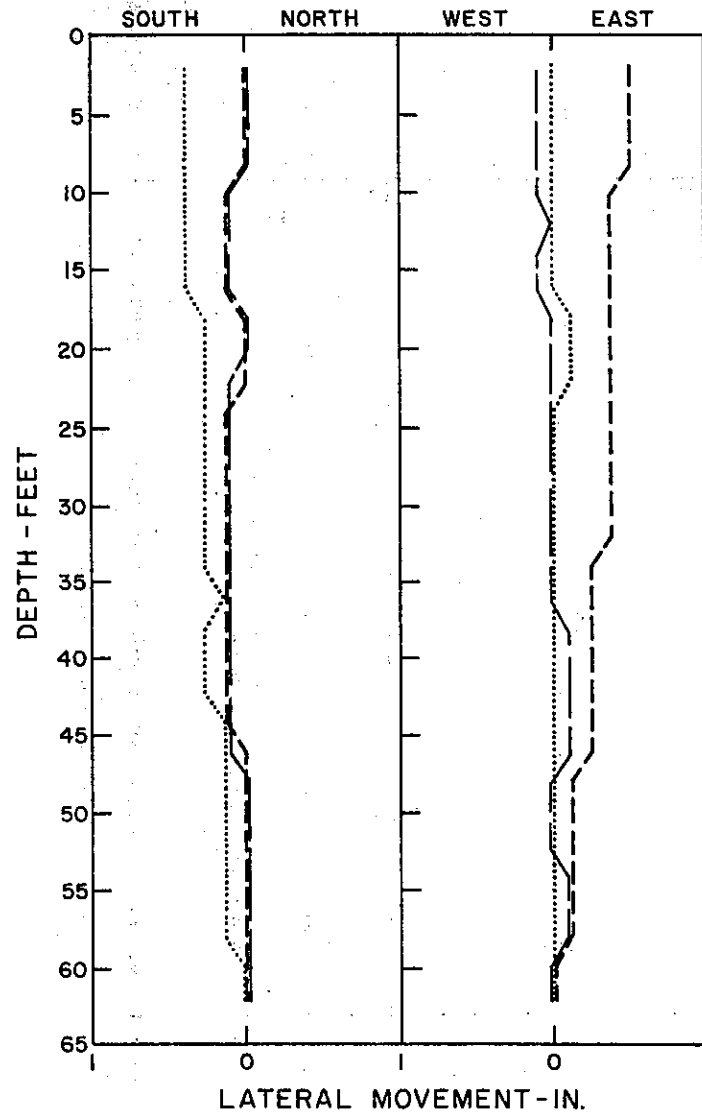
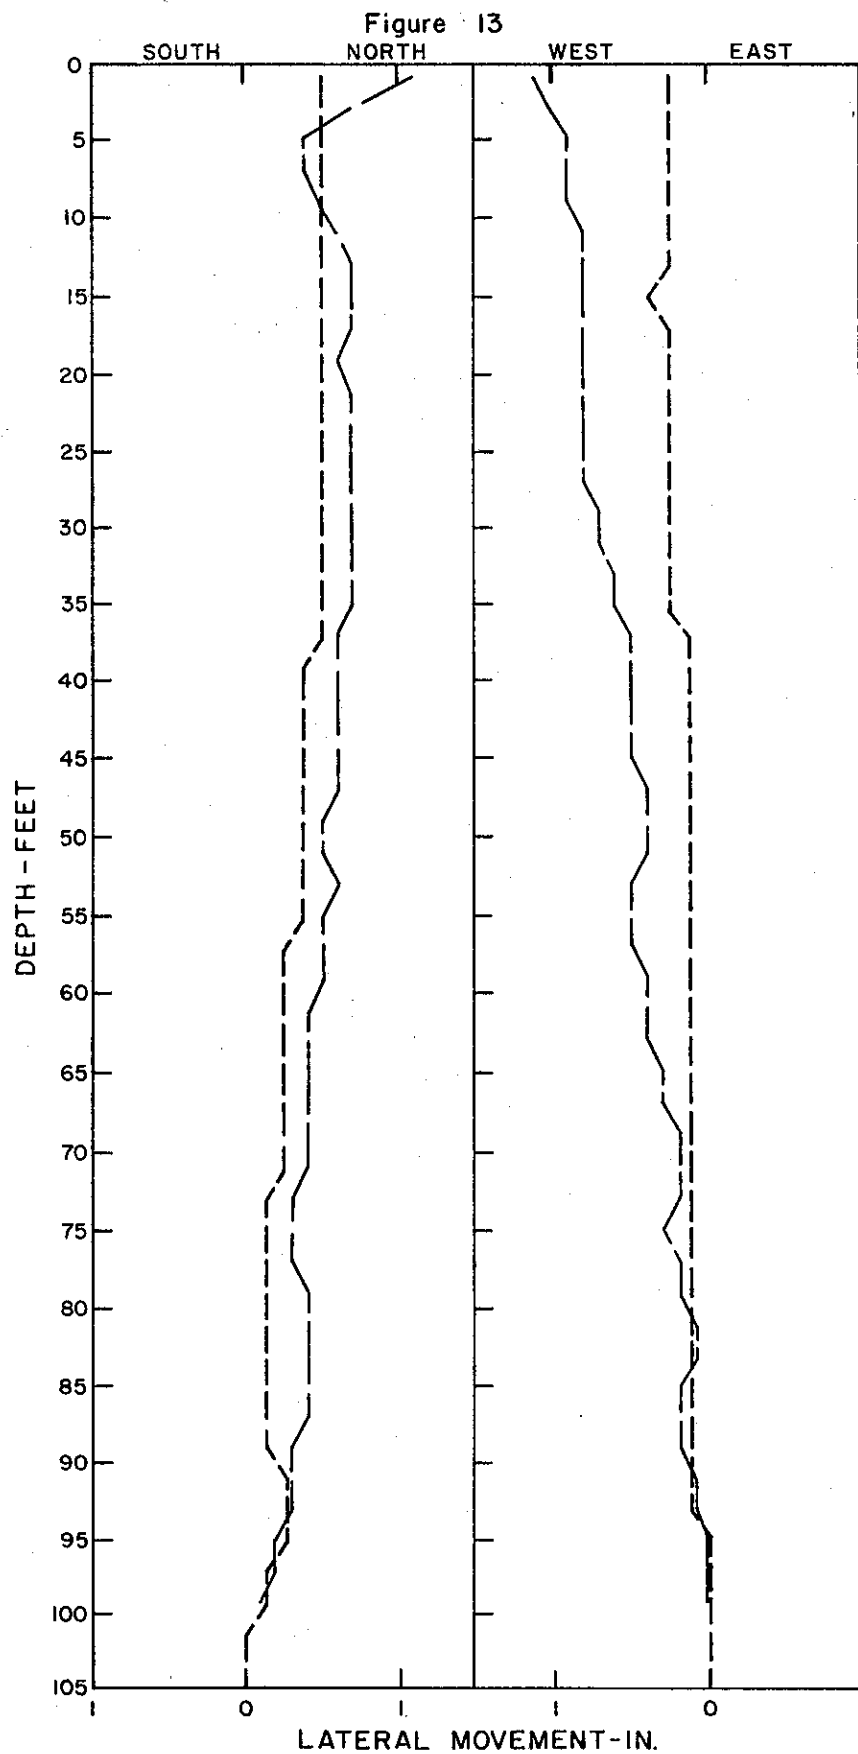
The results of the slope indicator monitoring are plotted in Figures 10 through 13. The data used in preparing these figures were arbitrarily selected from all of the slope indicator data obtained. For borings KBR-4, KBR-6 and SI-14 the three curves represent the beginning of monitoring (Oct. 2, 1970), just before the chemical treatment (April 21, 1971), and the completion of monitoring (March 27, 1972). For SI-35, only the before treatment and completion of monitoring data is available.

A clearly defined plane or zone of movement did not develop during the life of this project. Only very small movements occurred between consecutive readings and most of that was near the ground surface. In general, the same magnitude of movement occurred before and after the chemical treatment. Since the ground surface survey data did not indicate any evidence of significant movement down slope, the slope indicator data was interpreted as indicating internal adjustment and settlement within the slide mass.

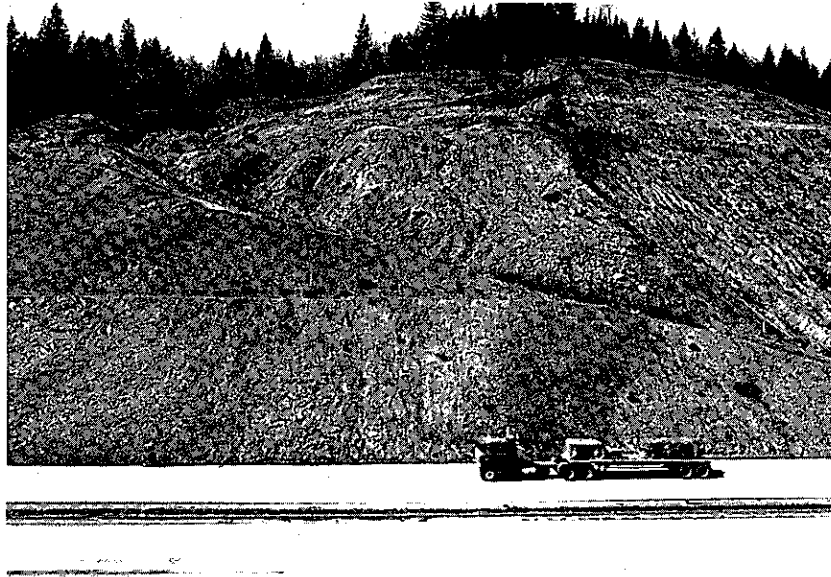
Plate 1 - Overall View

The slide which is pictured on Plates 1 and 2, is approximately 900 feet long and 400 feet wide with a maximum thickness of 100 feet. Figure 2 shows the topography at the time of this correction. It appears to be a very old landslide that was reactivated by construction of the highway cut in 1959. Correction work completed during construction consisted of slope flattening and the installation of horizontal drains. Although actual measurements have not been taken subsequent to construction, the movement appears to have continued since that time. The wet winters of 1964-65 and 1968-69 appear to have resulted in particularly large movements and the destruction of the horizontal drains installed during construction.

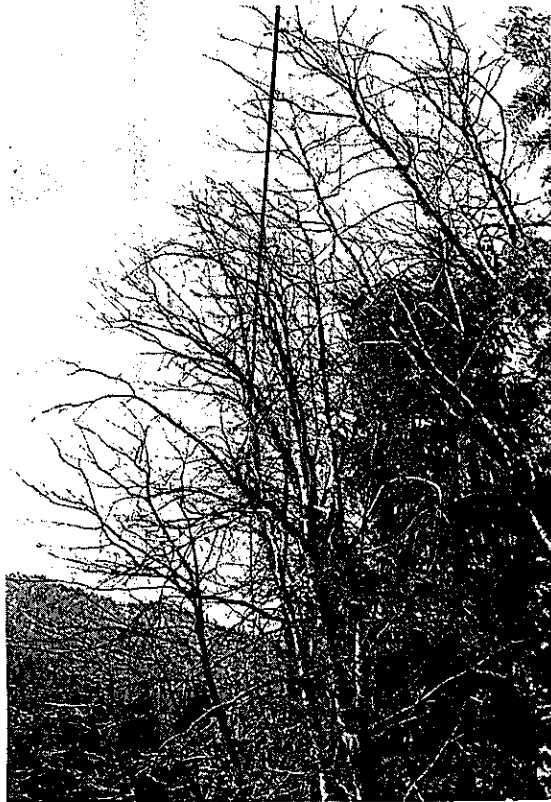
Plate 3

The movement was slow but perceptible as shown in Plate 3. The trees had, in one year, moved downhill enough to deflect the telephone cable. Plate 4 shows the cable after the trees were pruned by the phone company.

Trees deflecting
telephone line

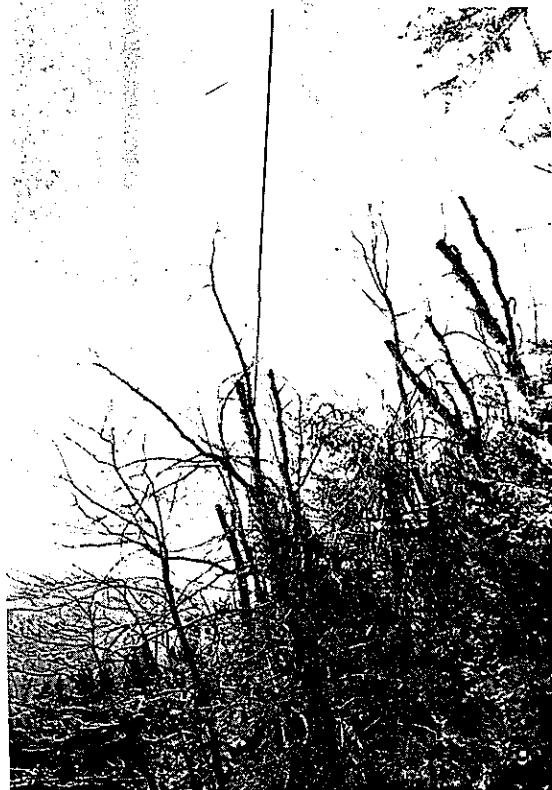
Plate 4

Same line after
trimming trees
